**Subsidence Documentation Study**  
**Sufco Mine**  
**May 30, 2003**  
**Summary**

The data contained in this binder is a compilation of subsidence features gathered in the field from the 19 of May to the 22 of May 2003. The features have been organized into five different sections representing panels in descending order starting with the most recent. At the beginning of each section is a summary sheet outlining important aspects of the panel with emphasis on subsidence features contained therein.

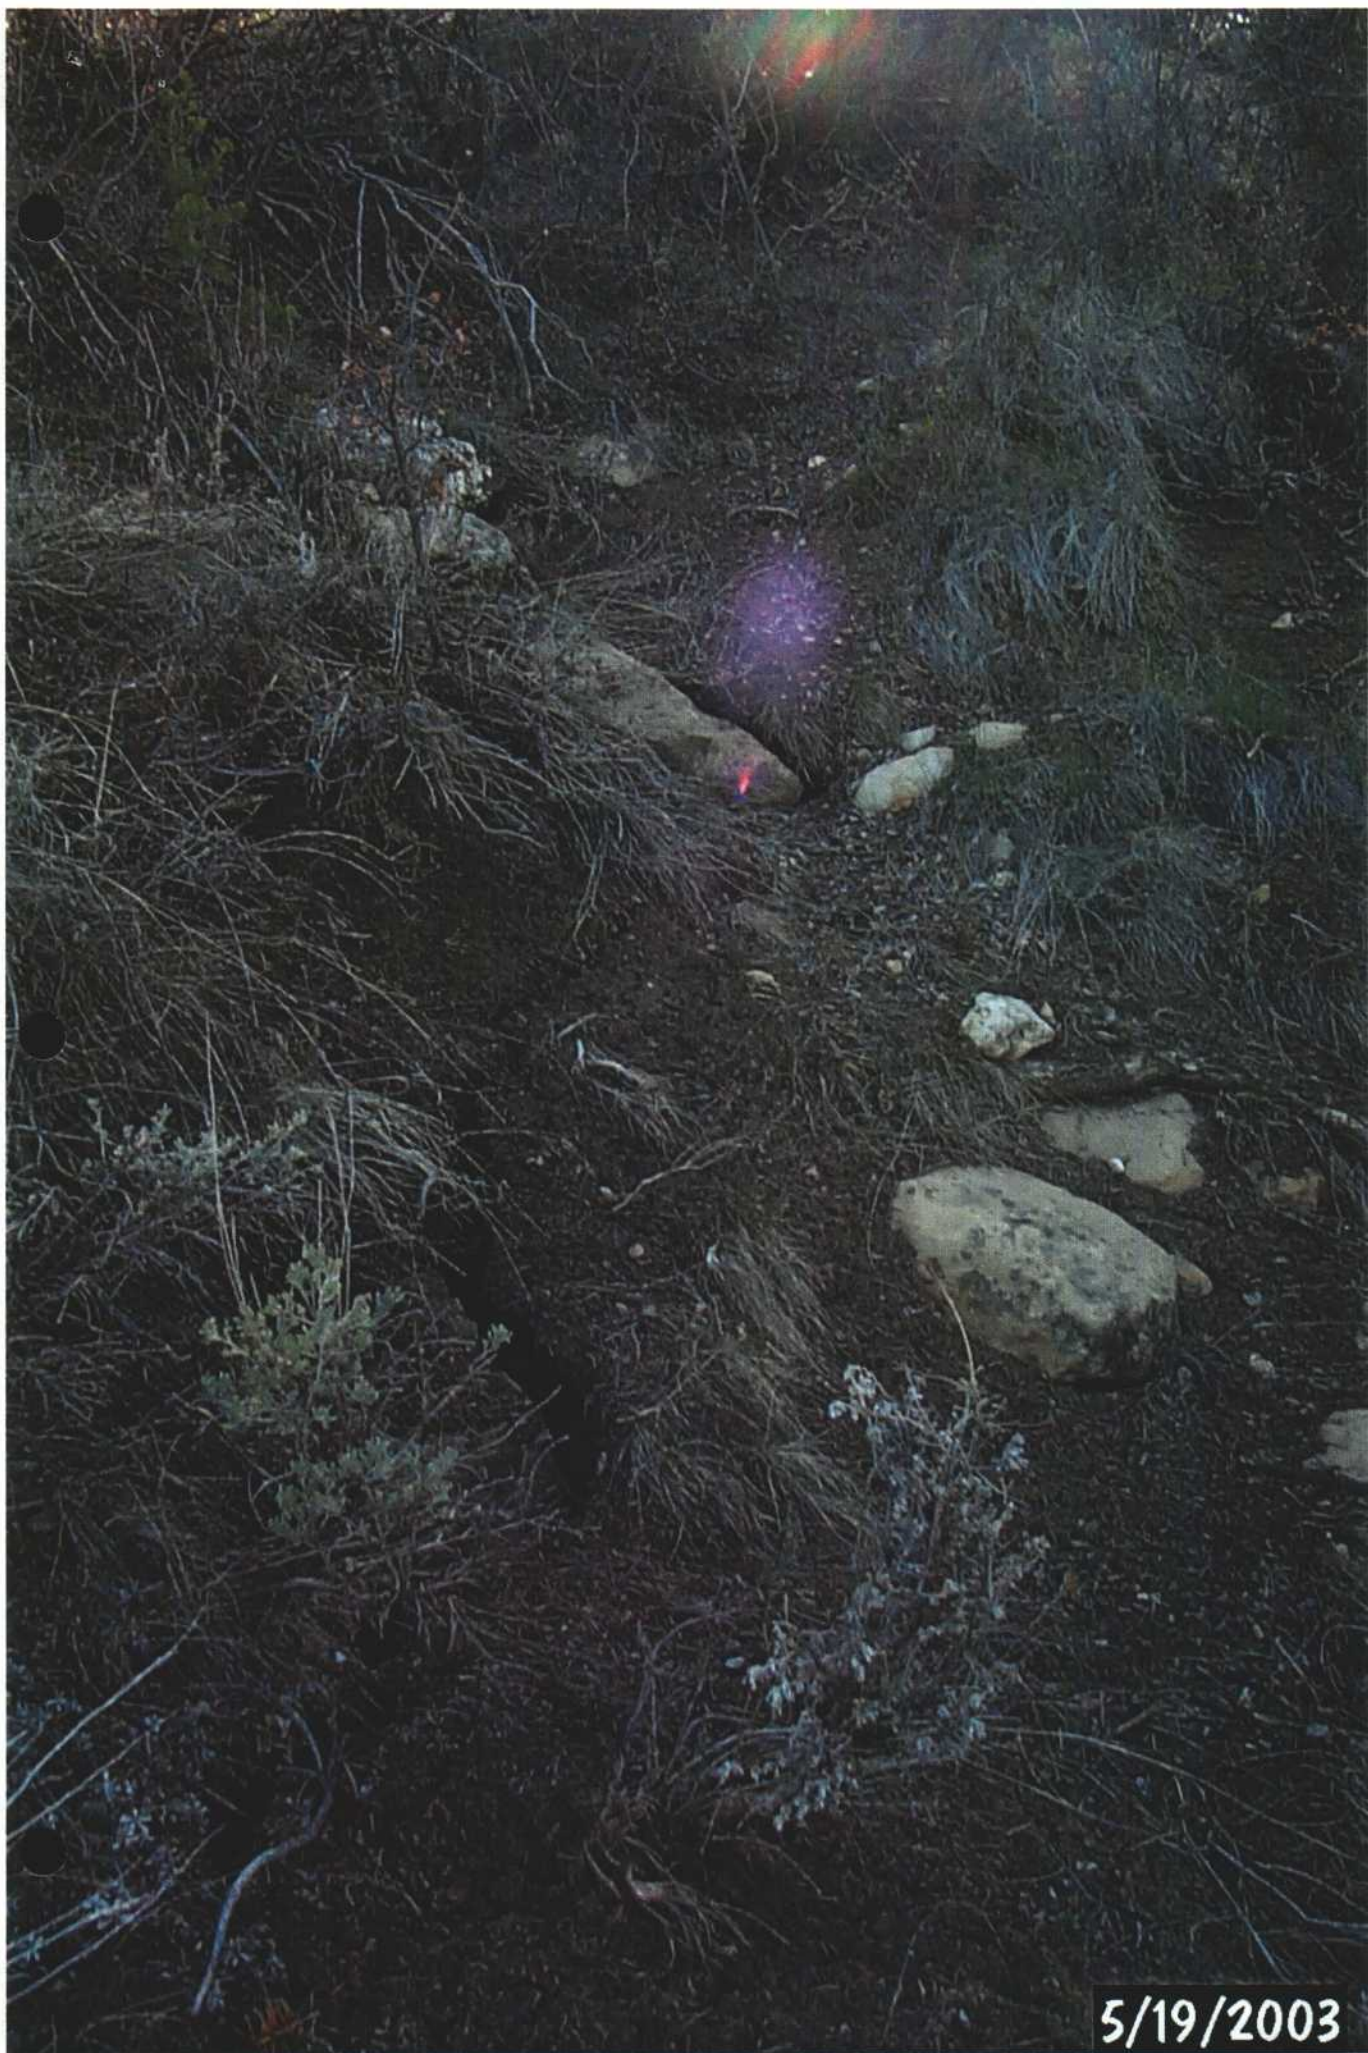
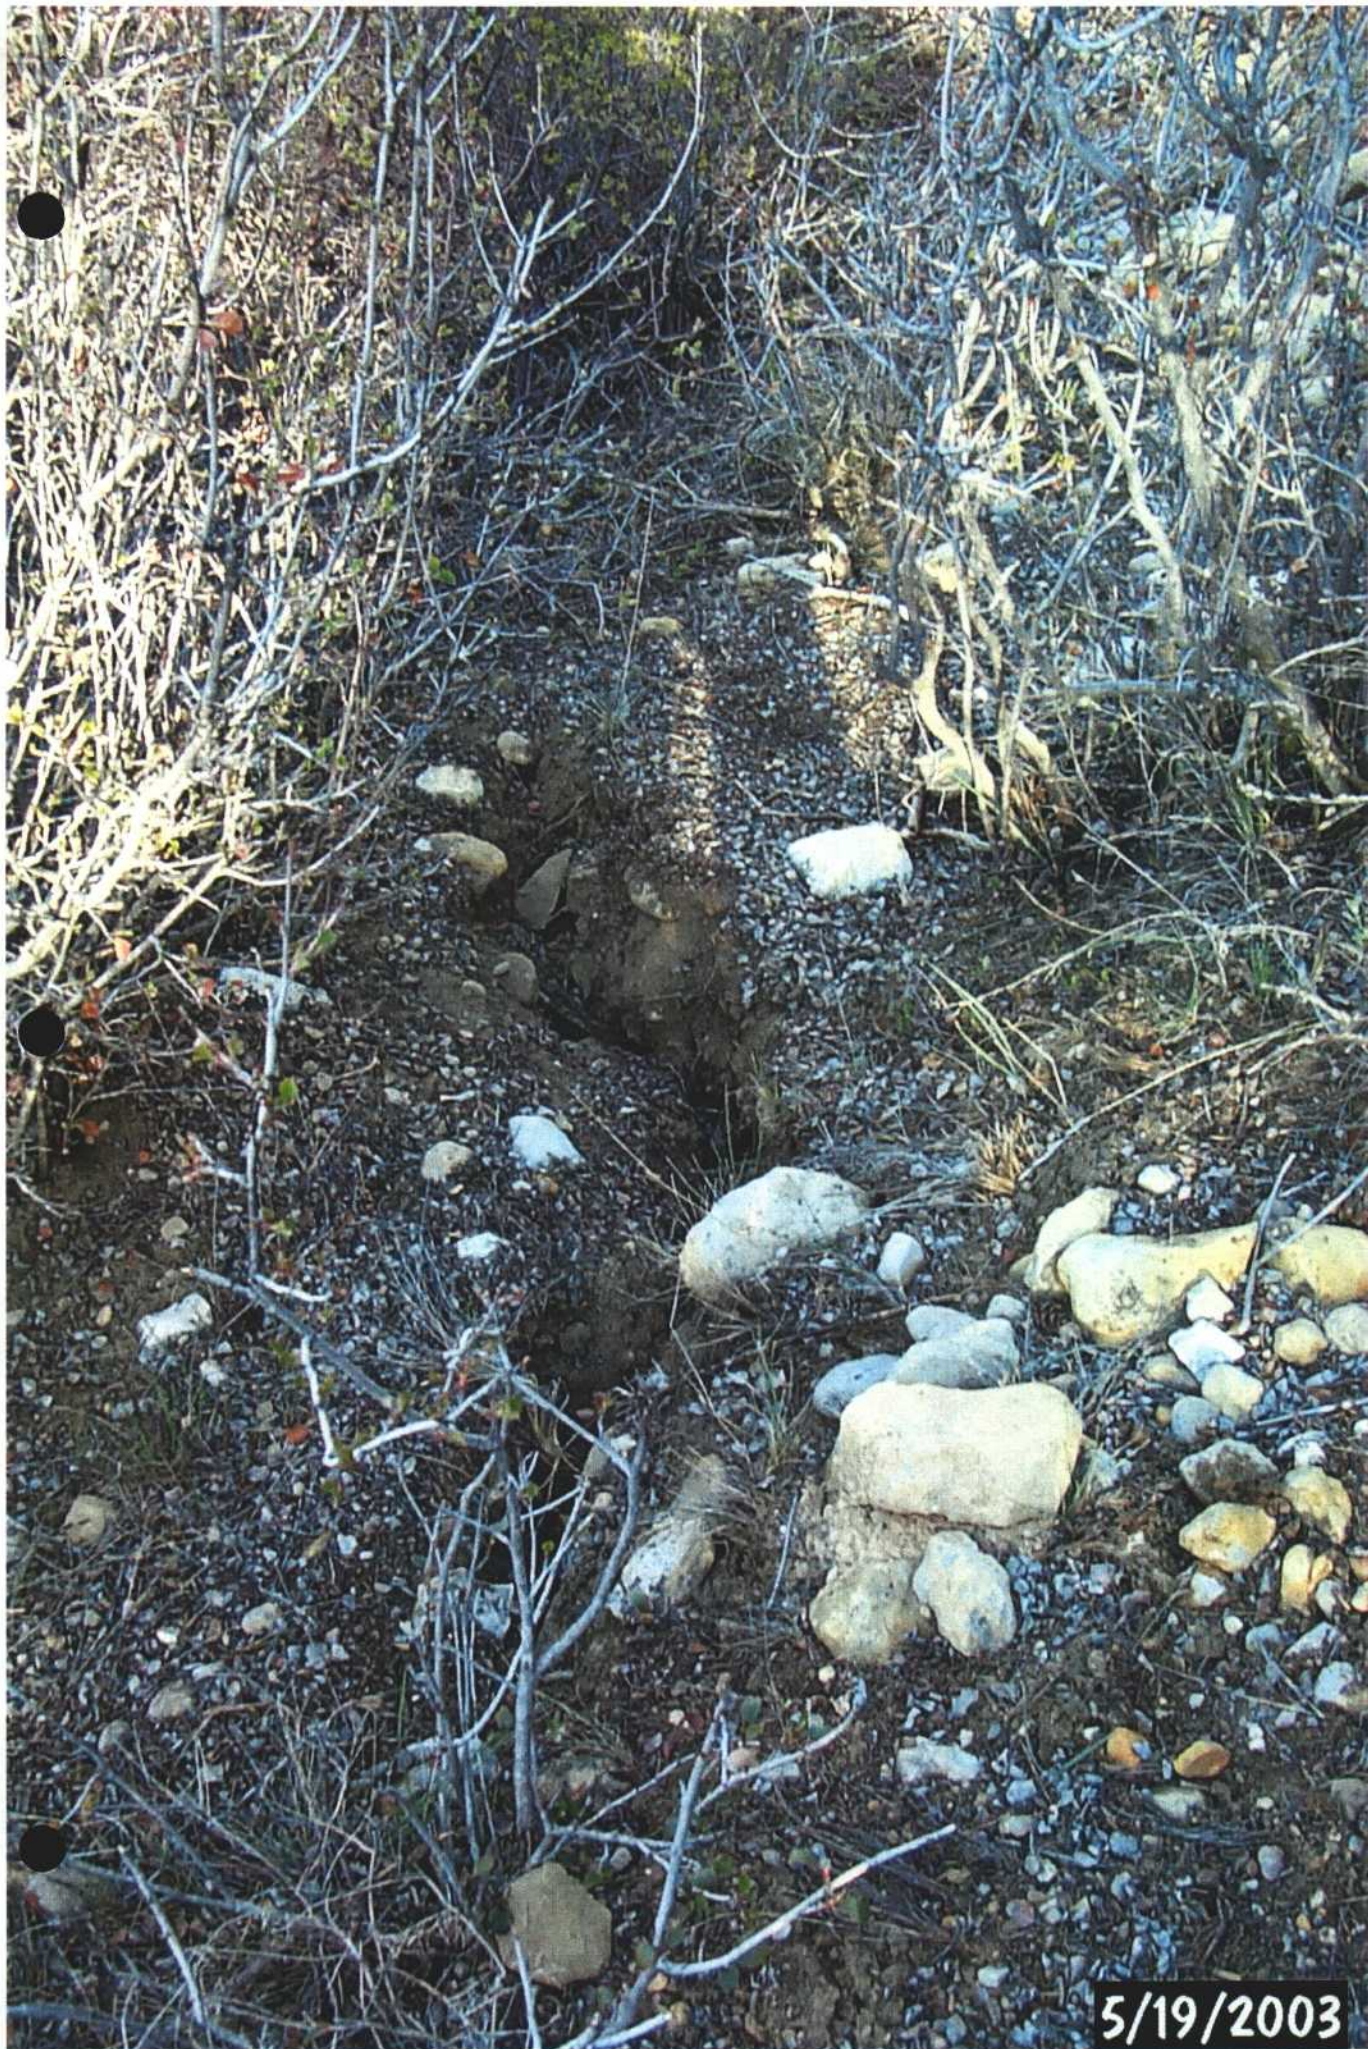
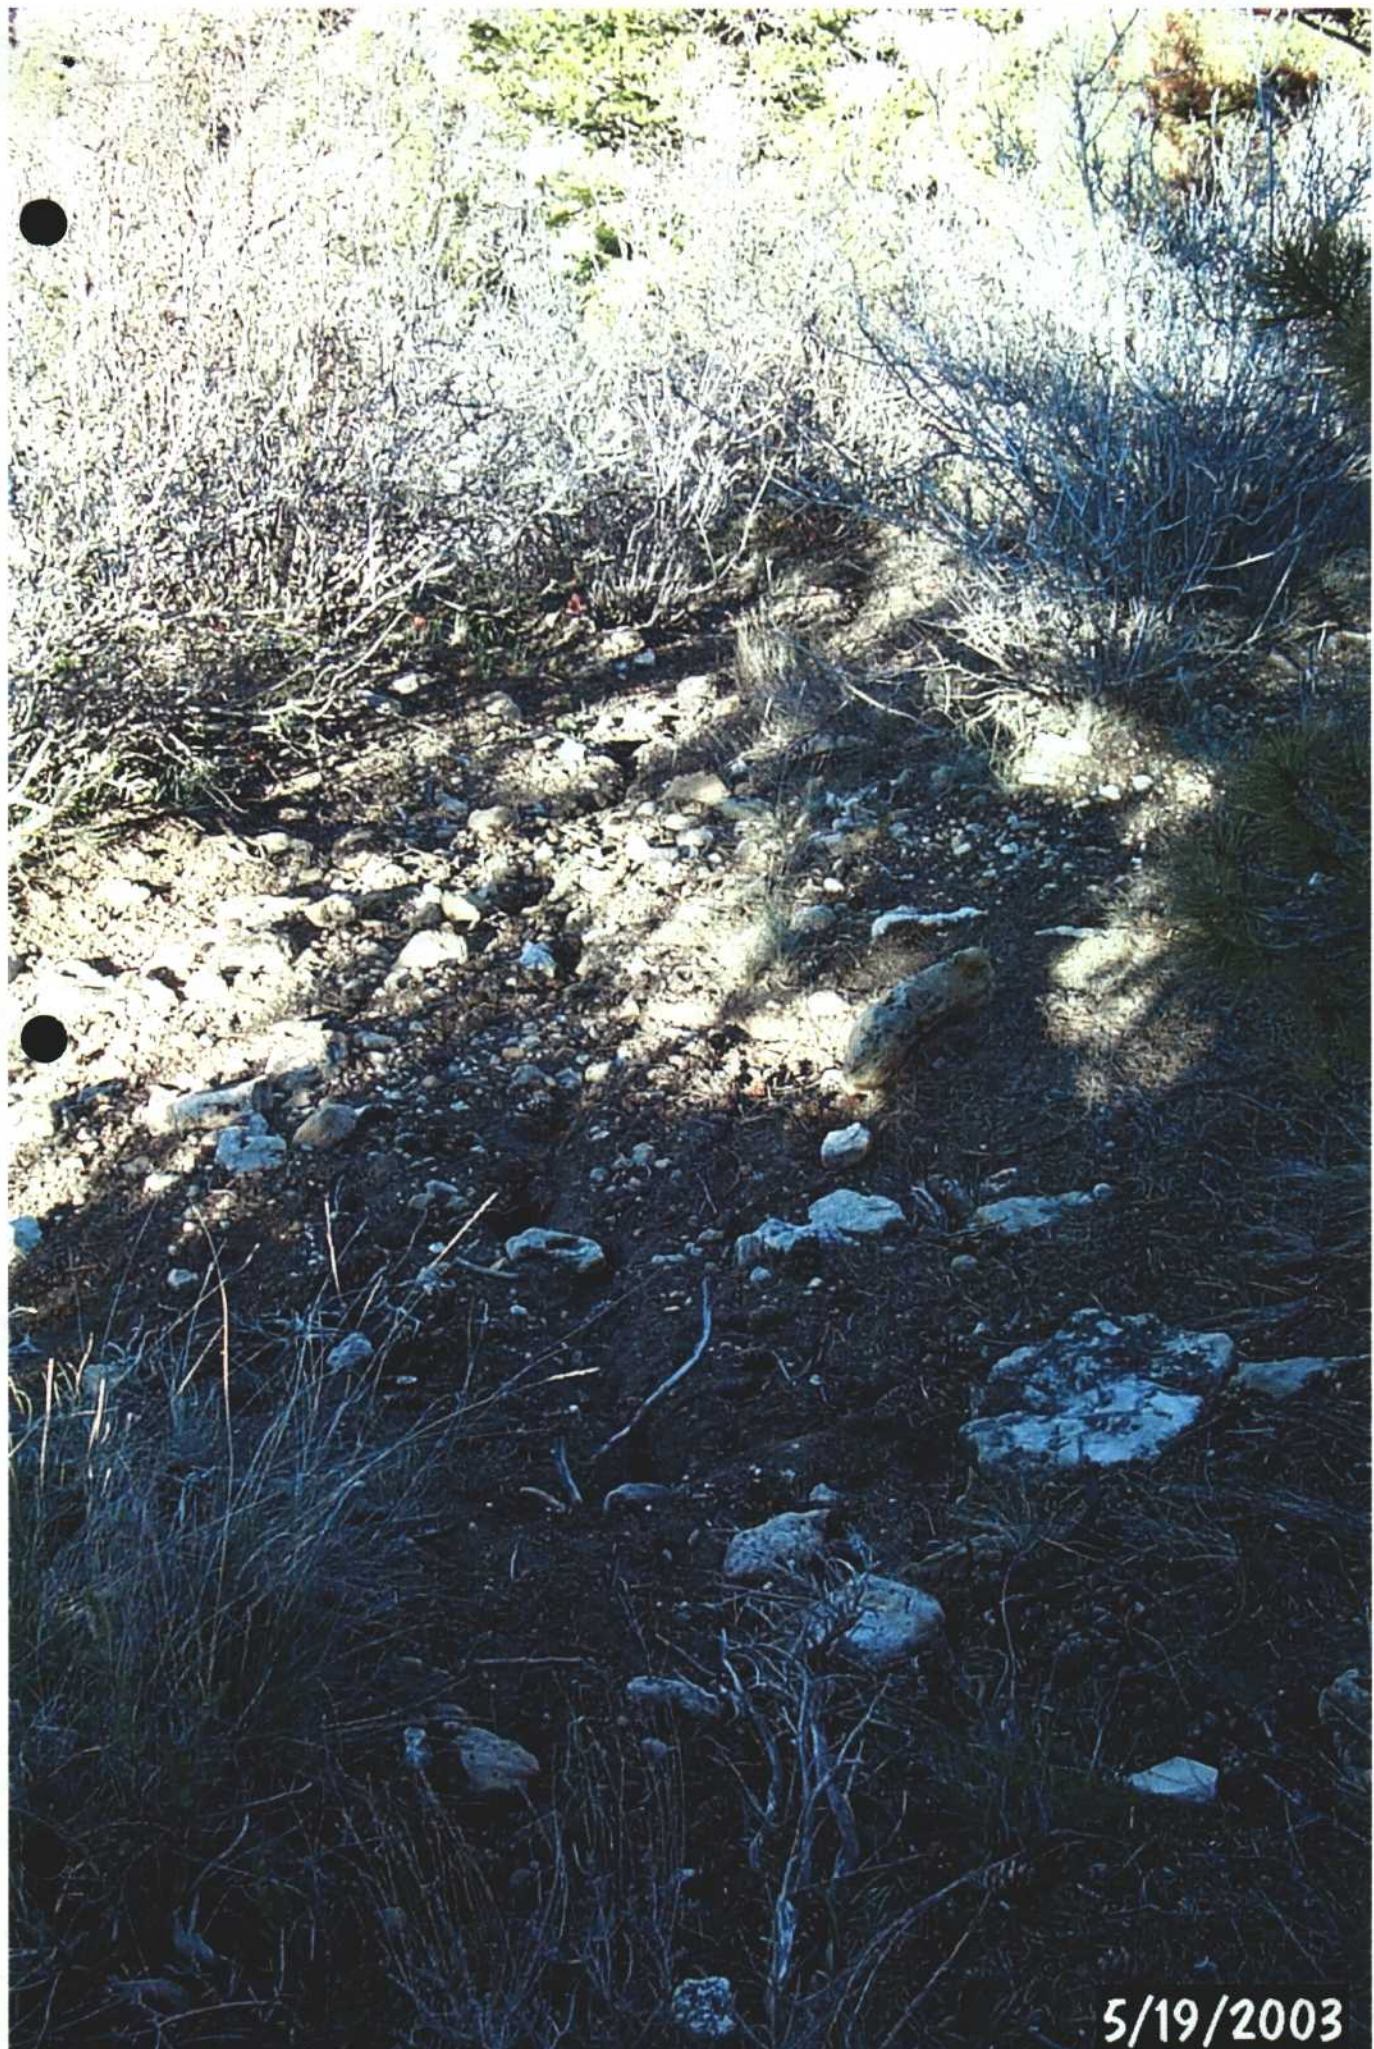
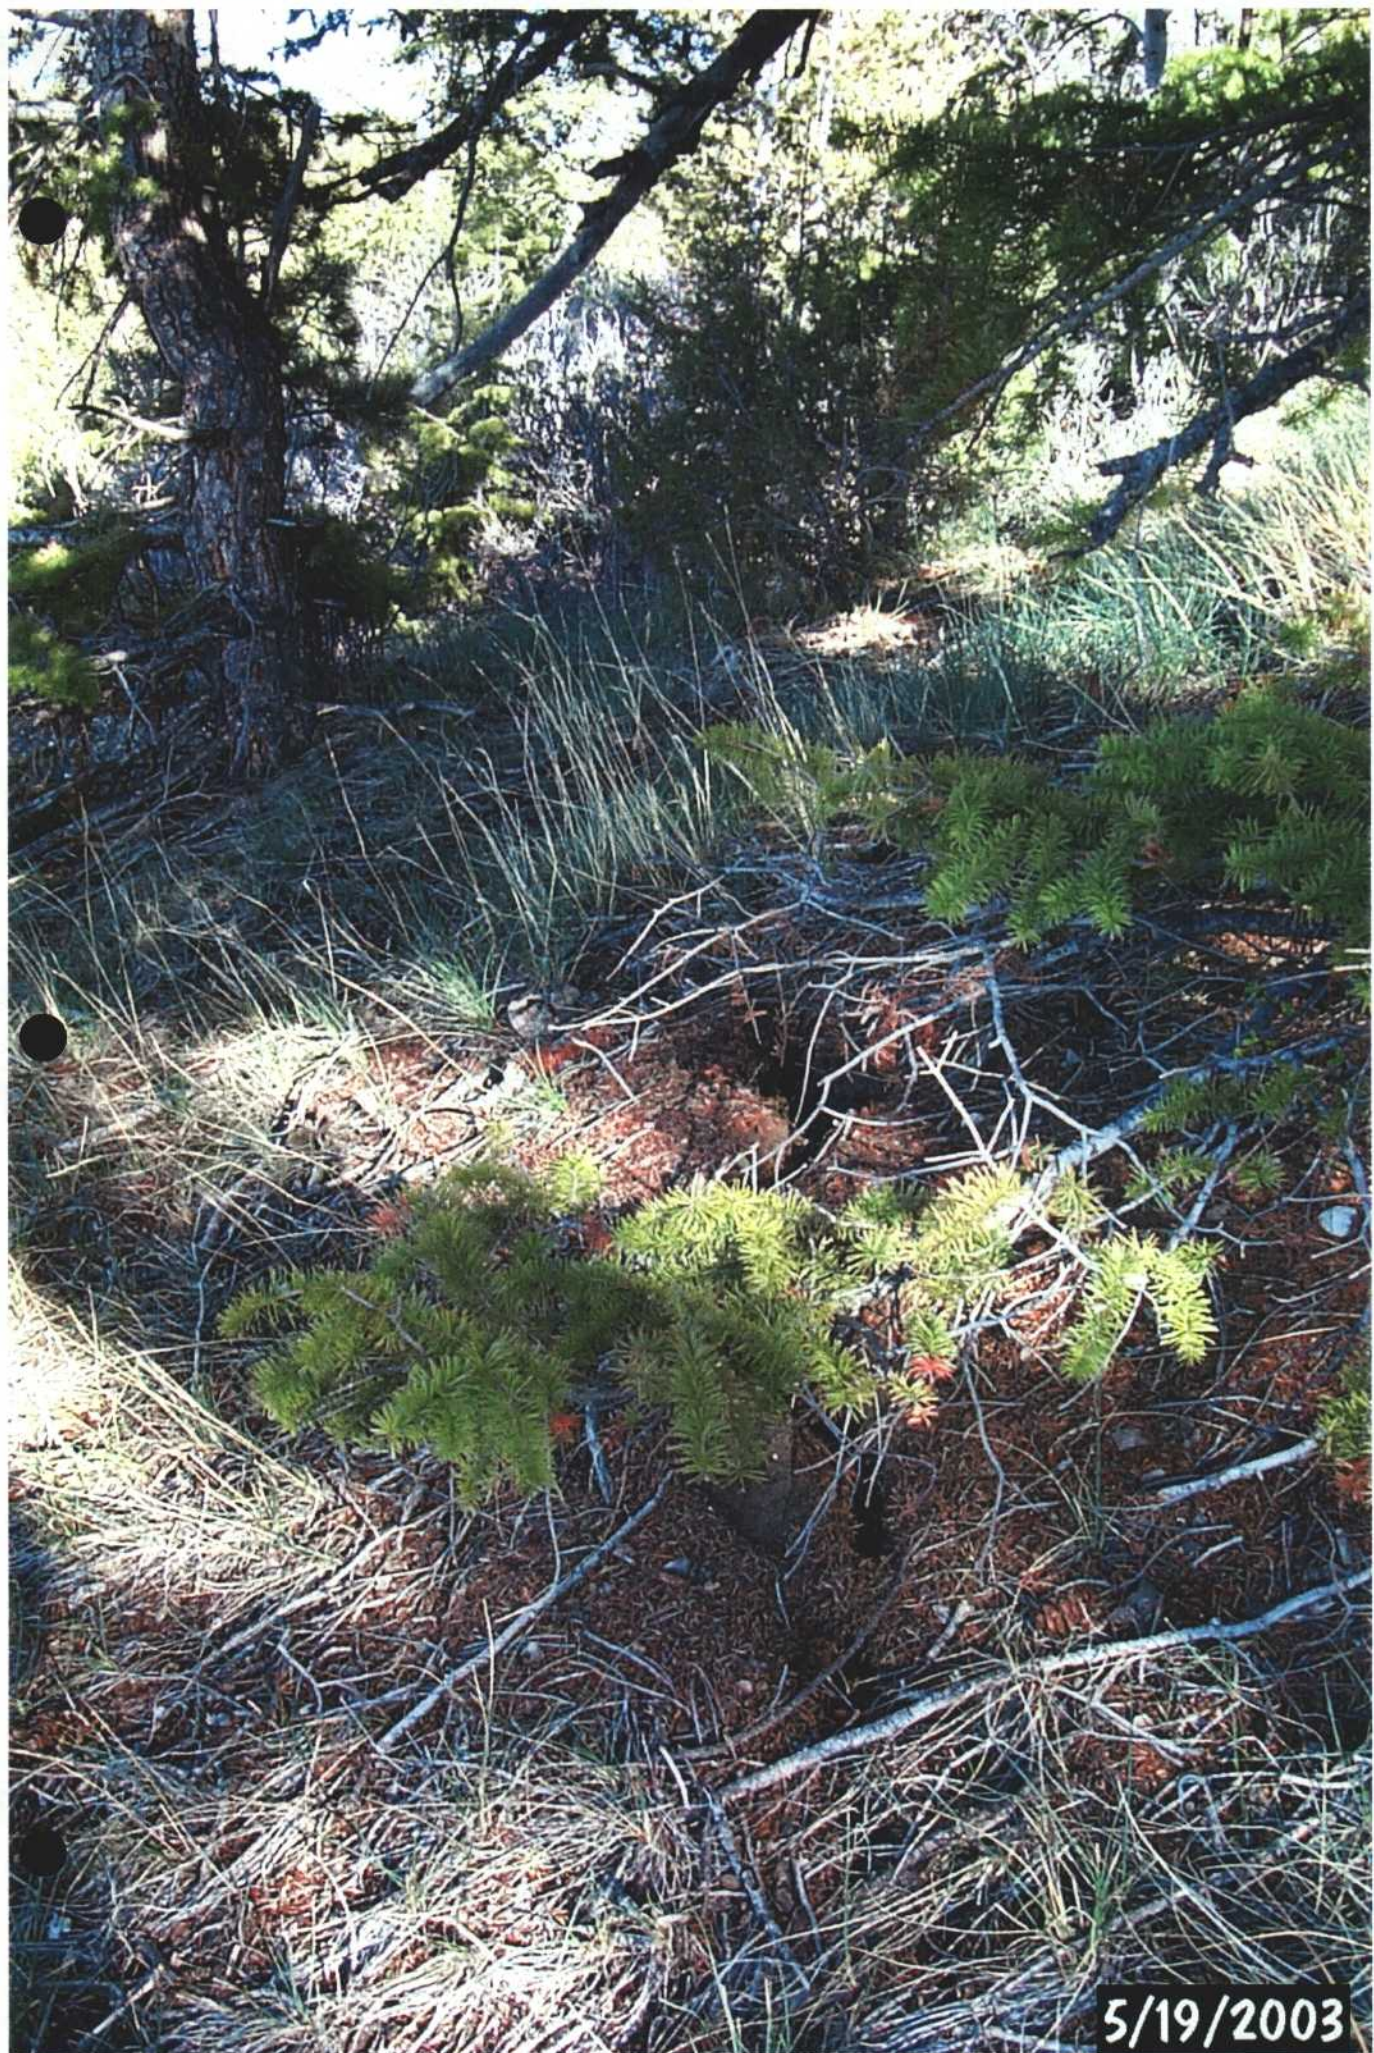
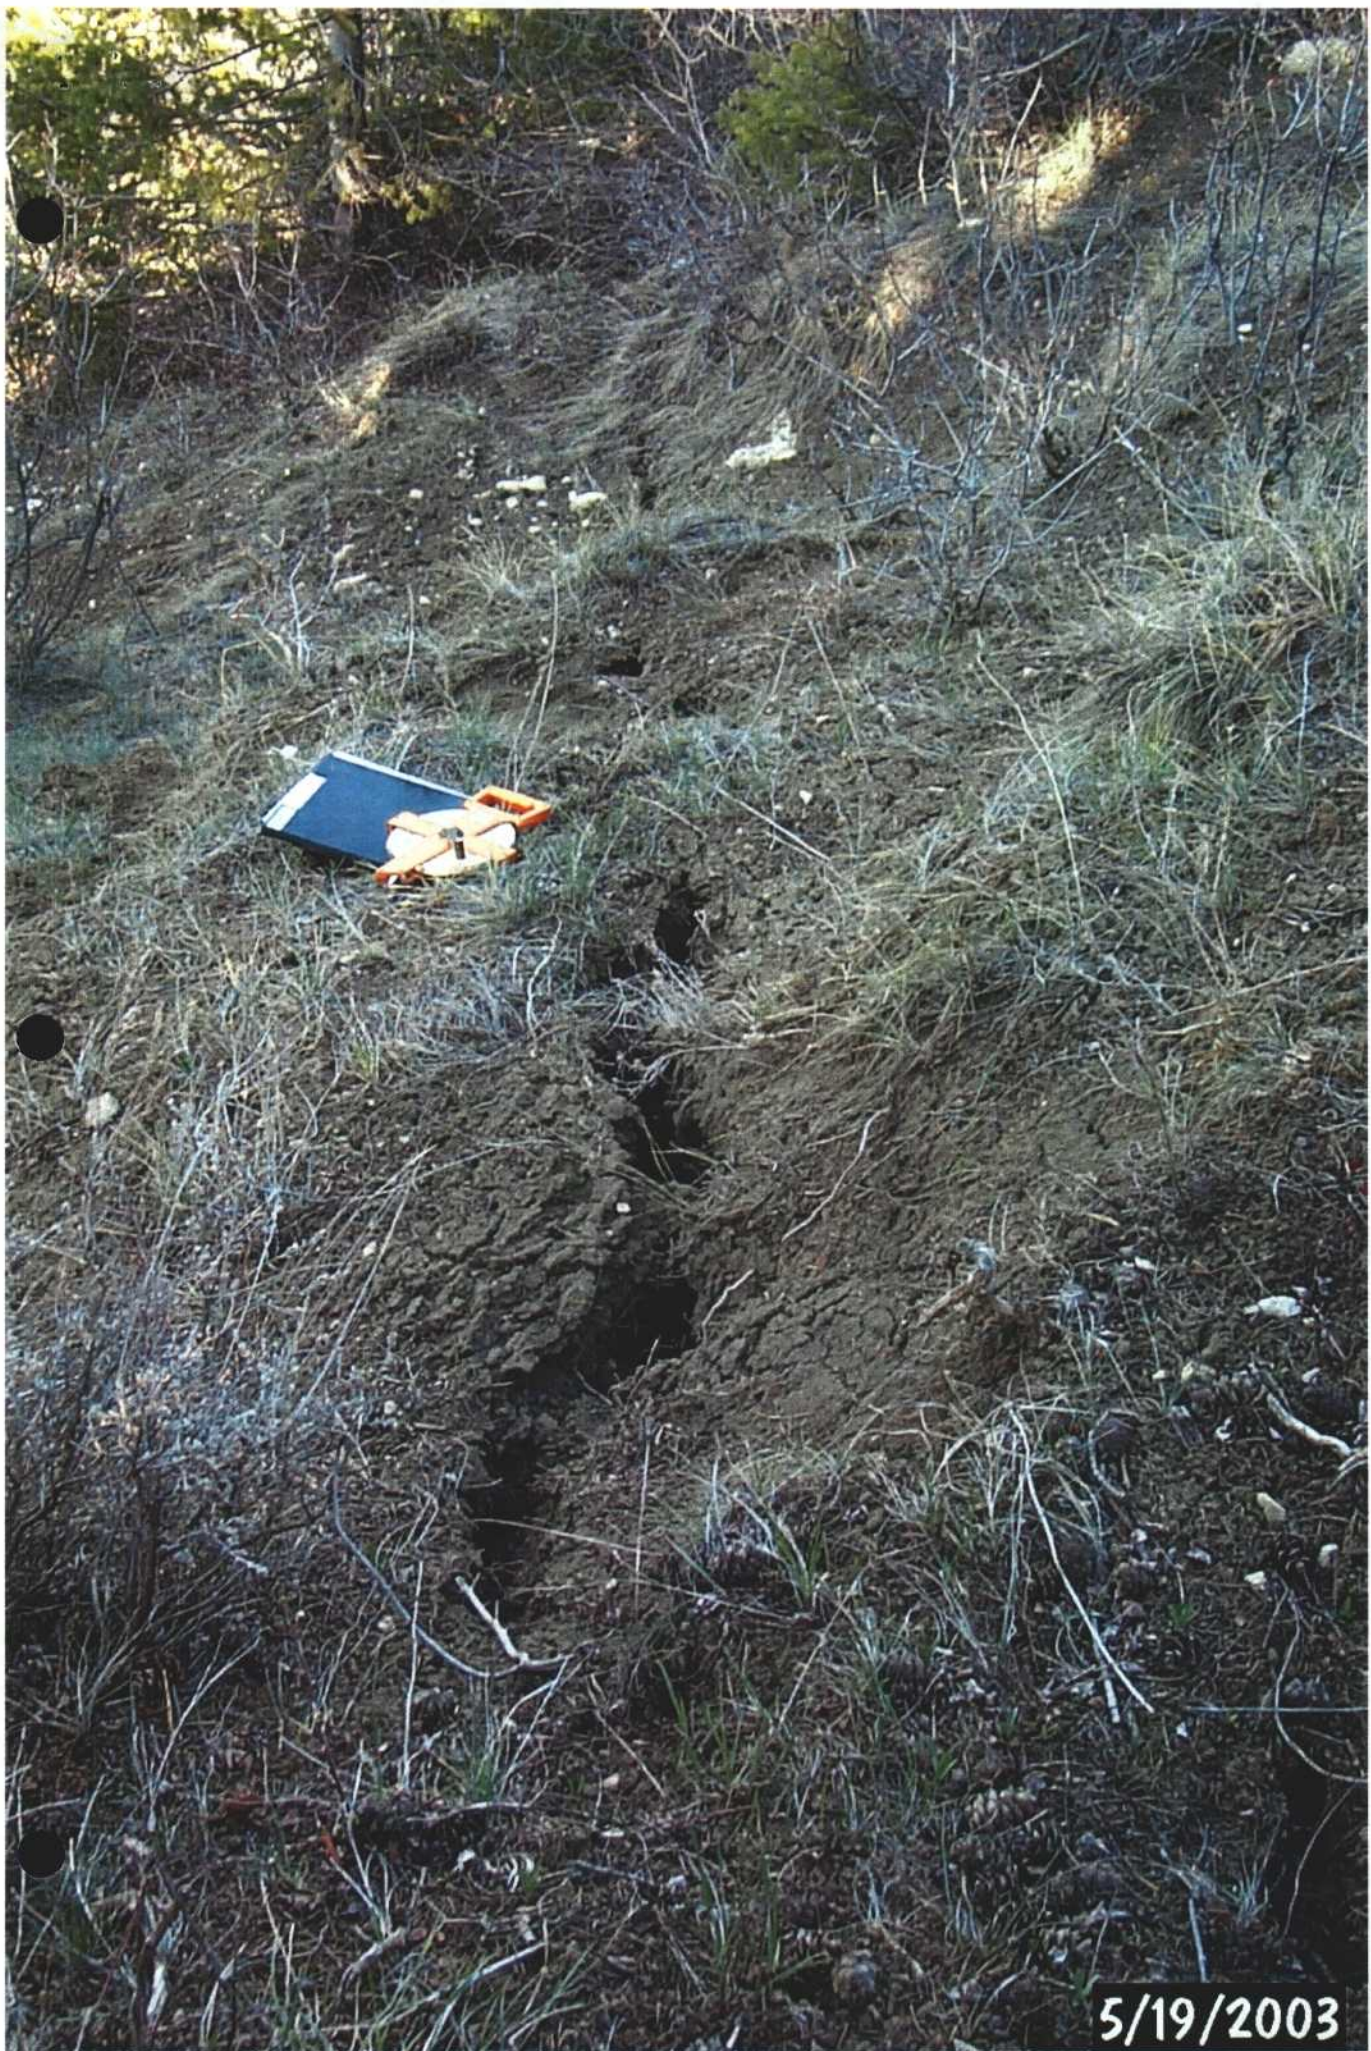
Panel: 1 left pines east Feature # 4

**Dimensions (in feet):** Crack is 240 feet long, and as wide as 9 inches in places.  
Immediate depth varies between 3 and 12 inches.

This crack is quite large, and should be watched. If it should grow any larger it may become a hazard. Some areas appear to have healed.

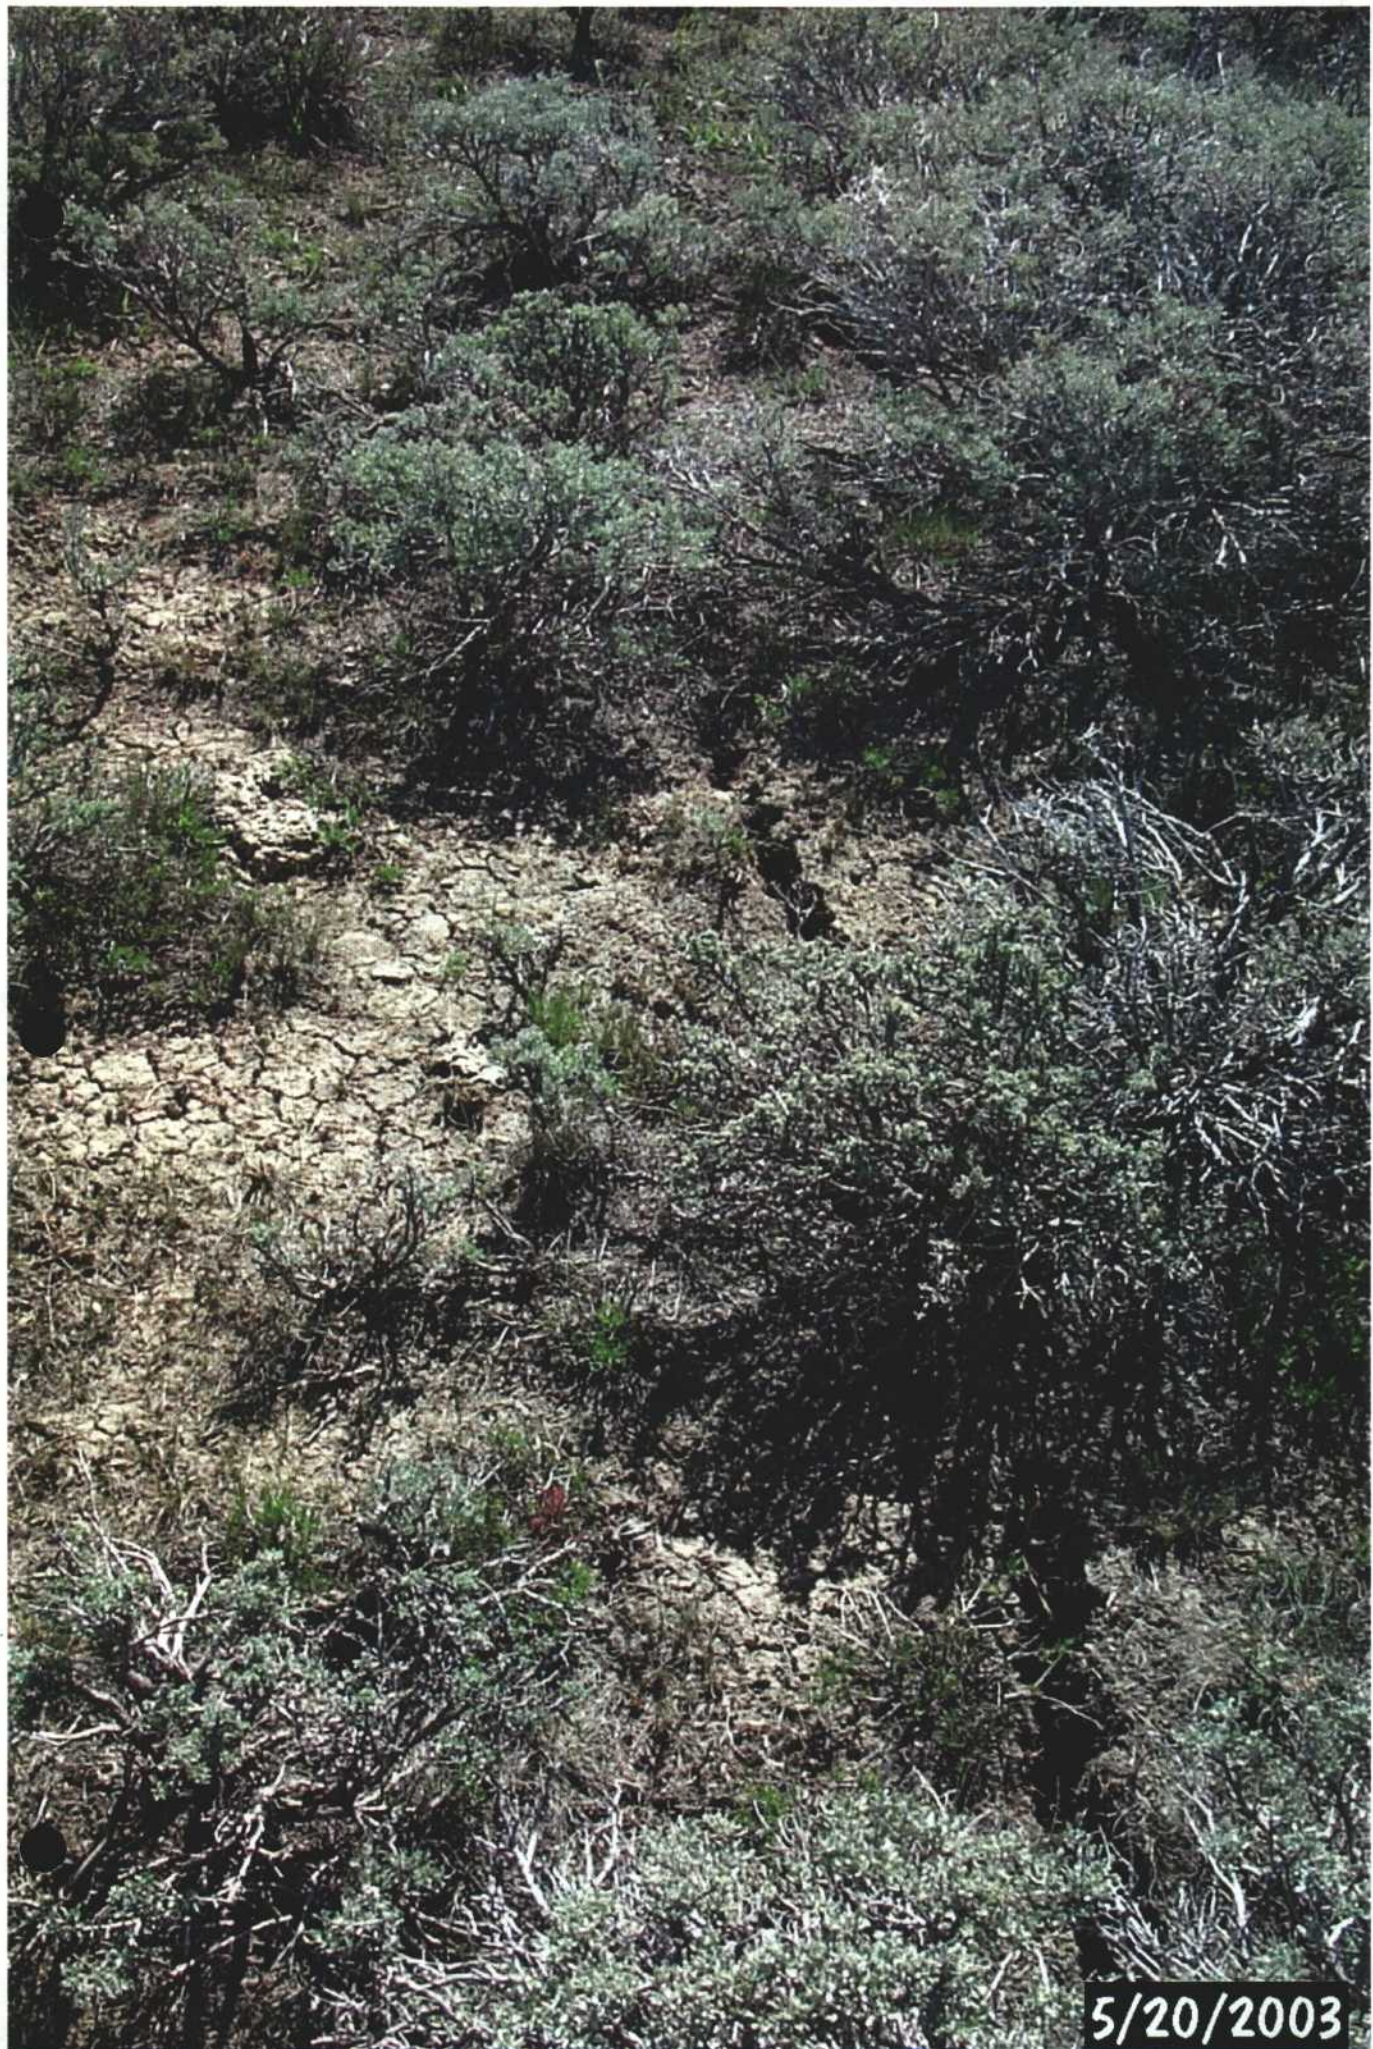
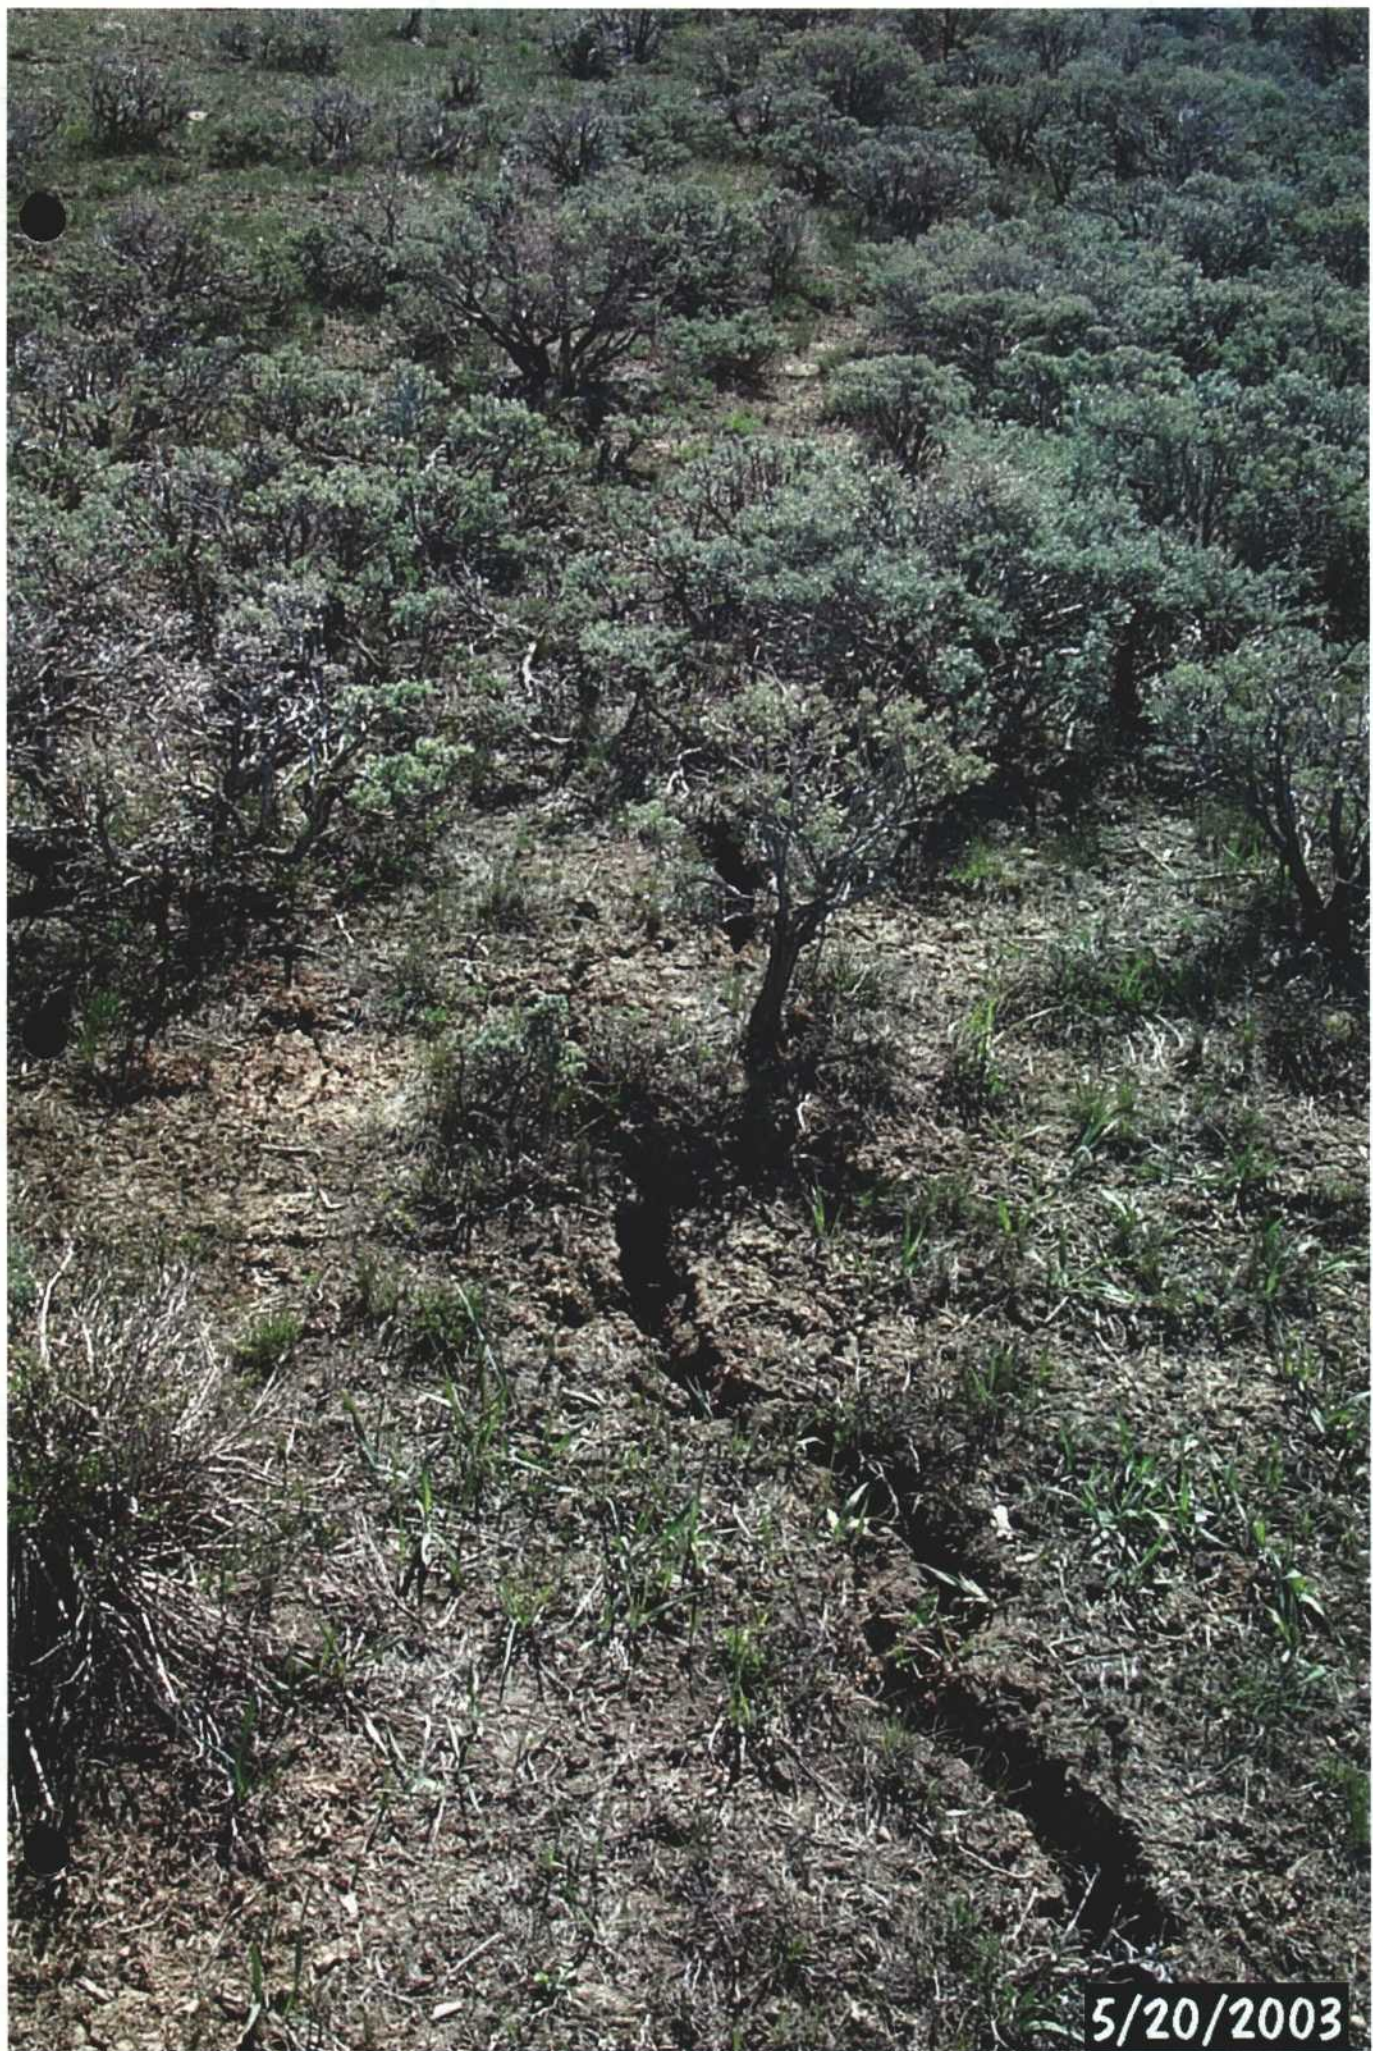
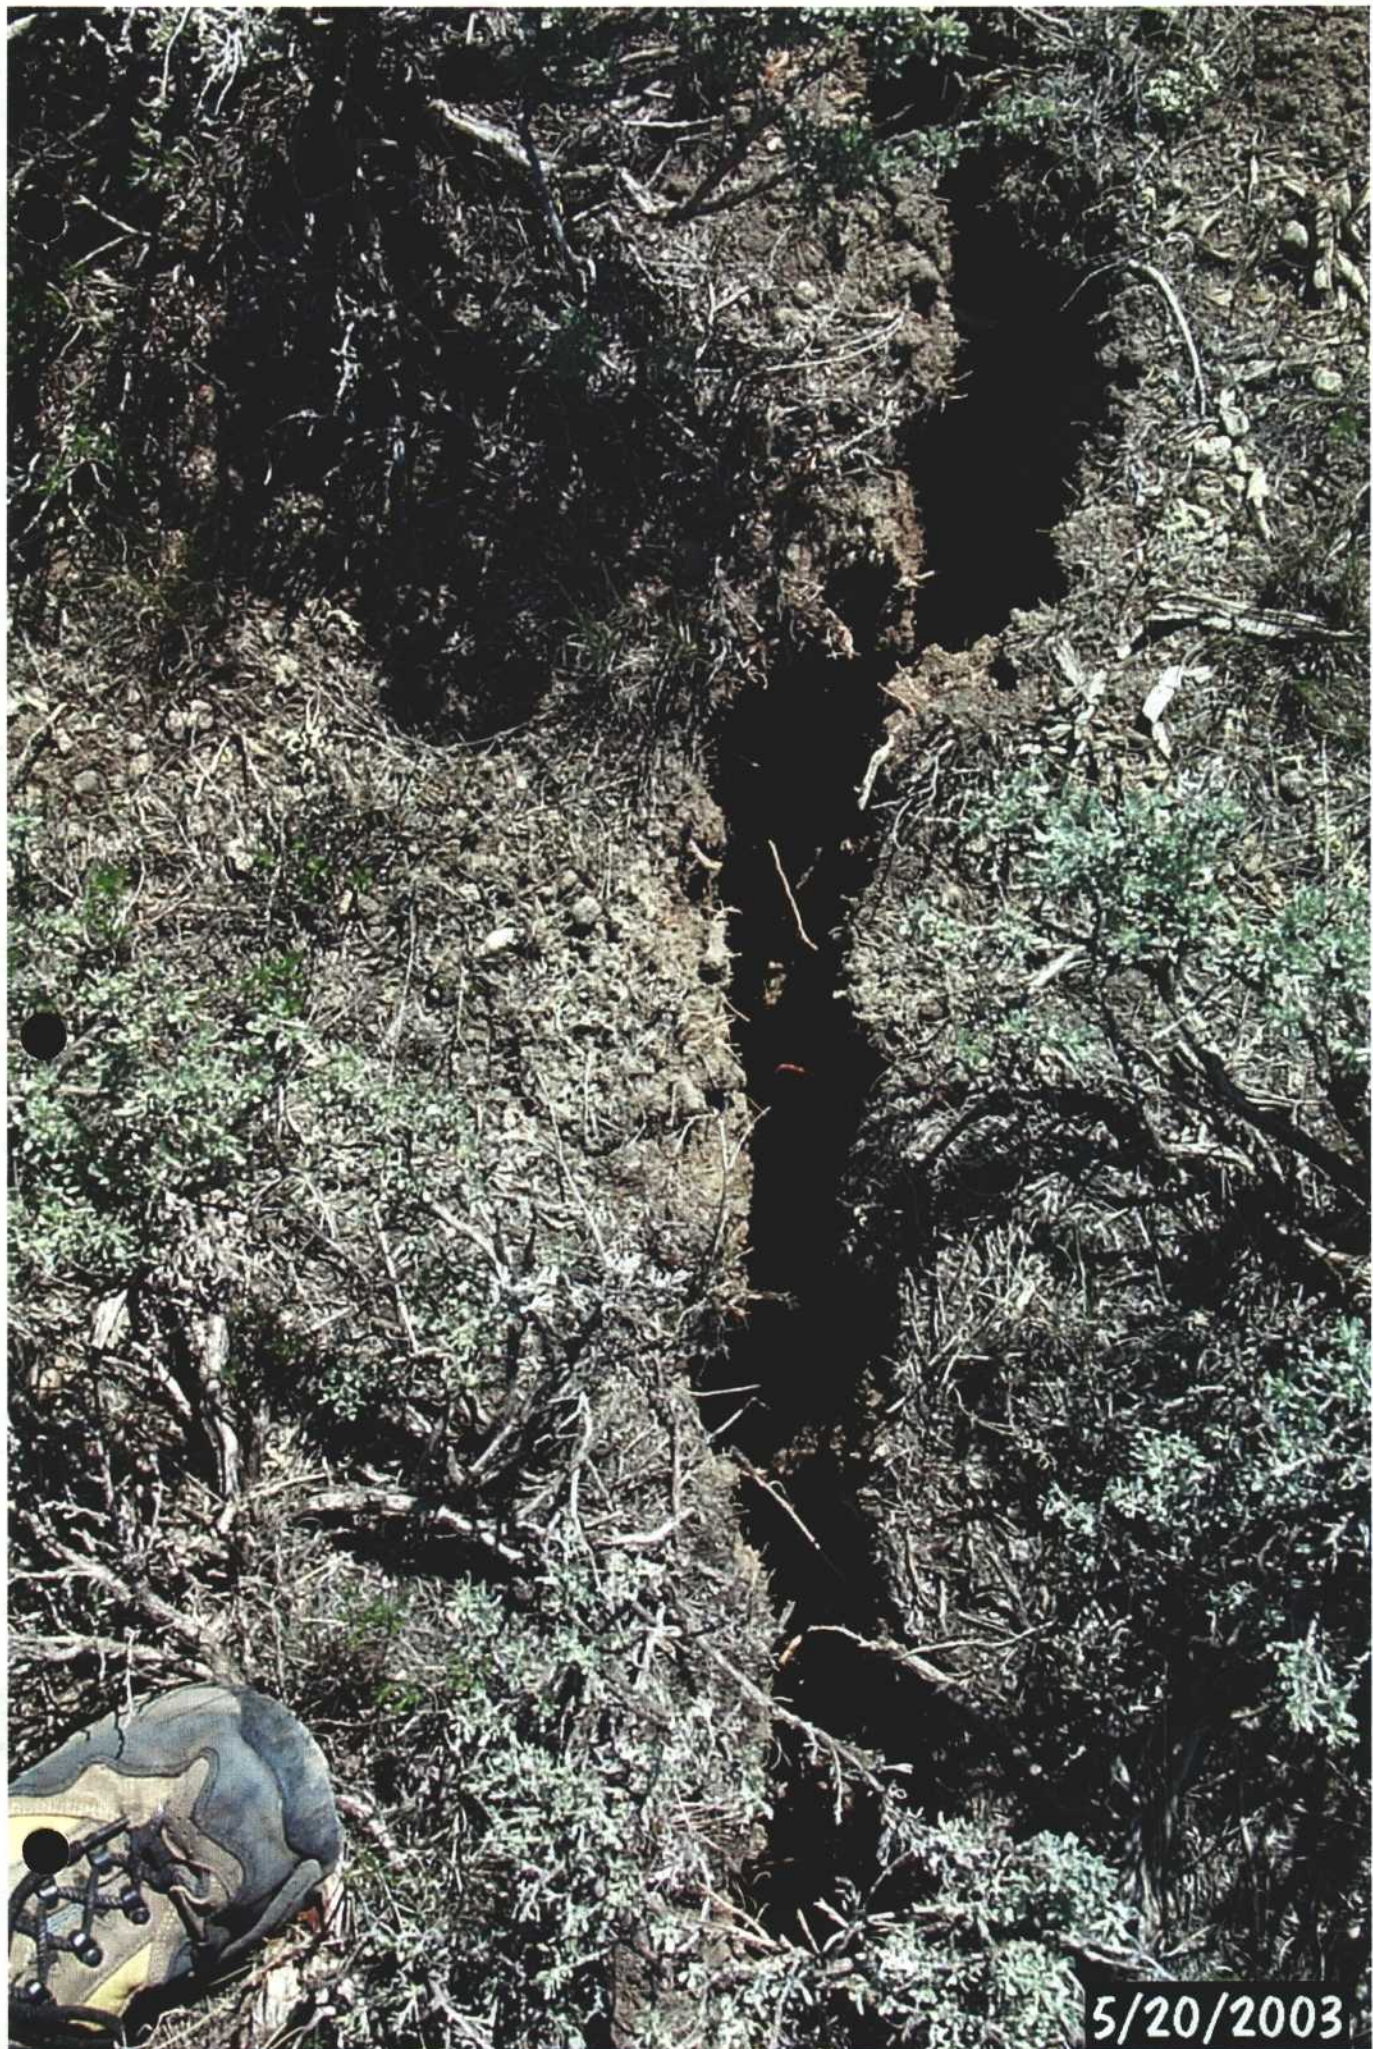
Panel: 1 left pines east Feature # 7

**Dimensions (in feet):** This crack is 116 feet long and up to 8 inches wide. Appears quite deep in places.

**Potential Hazards?** Since this crack is in the heart of grazing land, it may be a hazard to cattle.
